**Flood Control Project Maintenance
Levee Inspections**

Maintenance Issue Types Only, Levee Inspection Report By Mile - Spring 2020

Sacramento Maintenance Yard East Levee Yolo Bypass

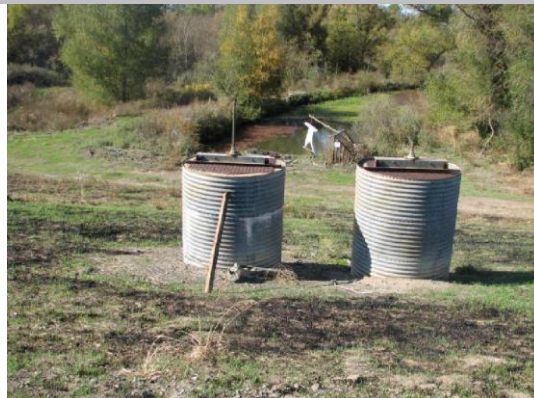
Photo 1 of 3 : UCIP_SP_2020_53253_60261.jpg

| UCIP Comments: 11/16/17 Ted Skidgel, pipe is closed on w/s and closed on L/S. Mud removed recently from WS pipes. | | | | | | |

Waterside view: overview CMP standpipe and water body

| Repair Type: No Action Needed | | | | | | |

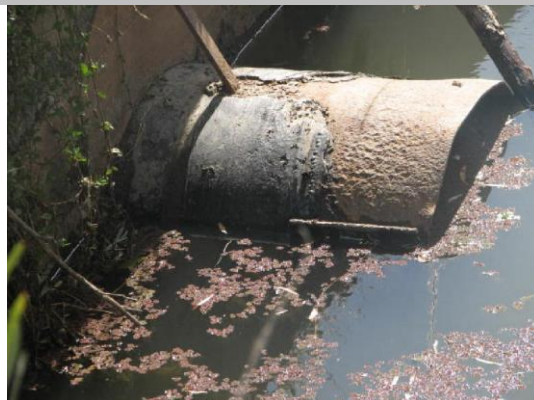
Photo 2 of 3 : UCIP_SP_2020_53253_60260.jpg

Waterside view: steel pipe and concrete headwall

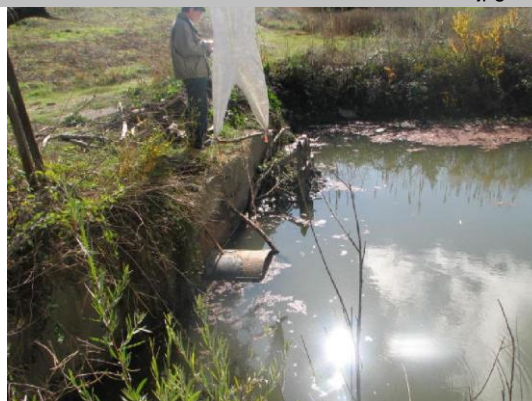
Photo 3 of 3 : UCIP_SP_2020_53253_60259.jpg

Waterside view: overview steel pipes and concrete headwall

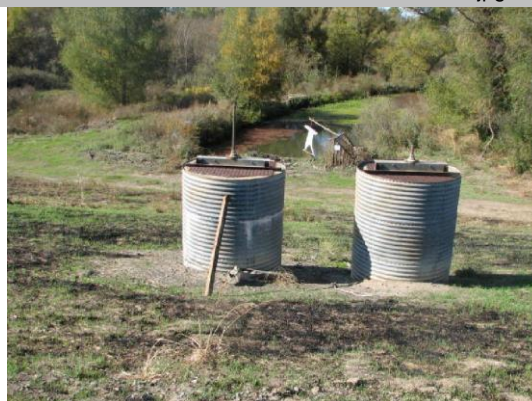
Photo 1 of 3 : UCIP_SP_2020_53254_60269.jpg

Waterside view: overview of CMP standpipe and water body

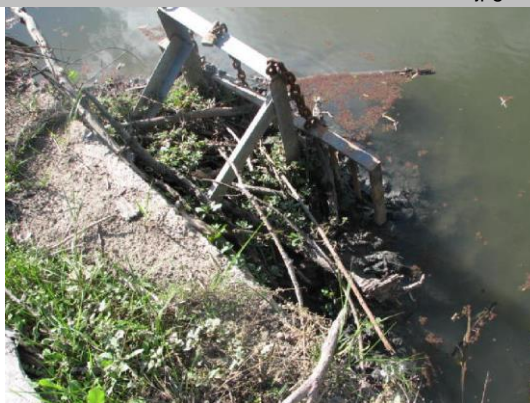
Photo 2 of 3 : UCIP_SP_2020_53254_60268.jpg

Waterside view: mud clogged pipe, trash rack and headwall

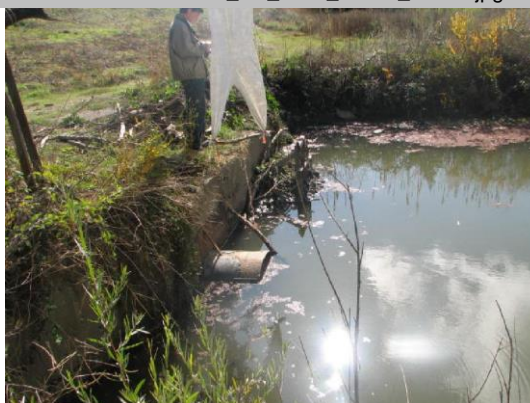
Photo 3 of 3 : UCIP_SP_2020_53254_60267.jpg

Waterside view: overview pipes and headwall
